Arecibo Inspection Photo Album

April 22, 2008

by Carl F. Plössl

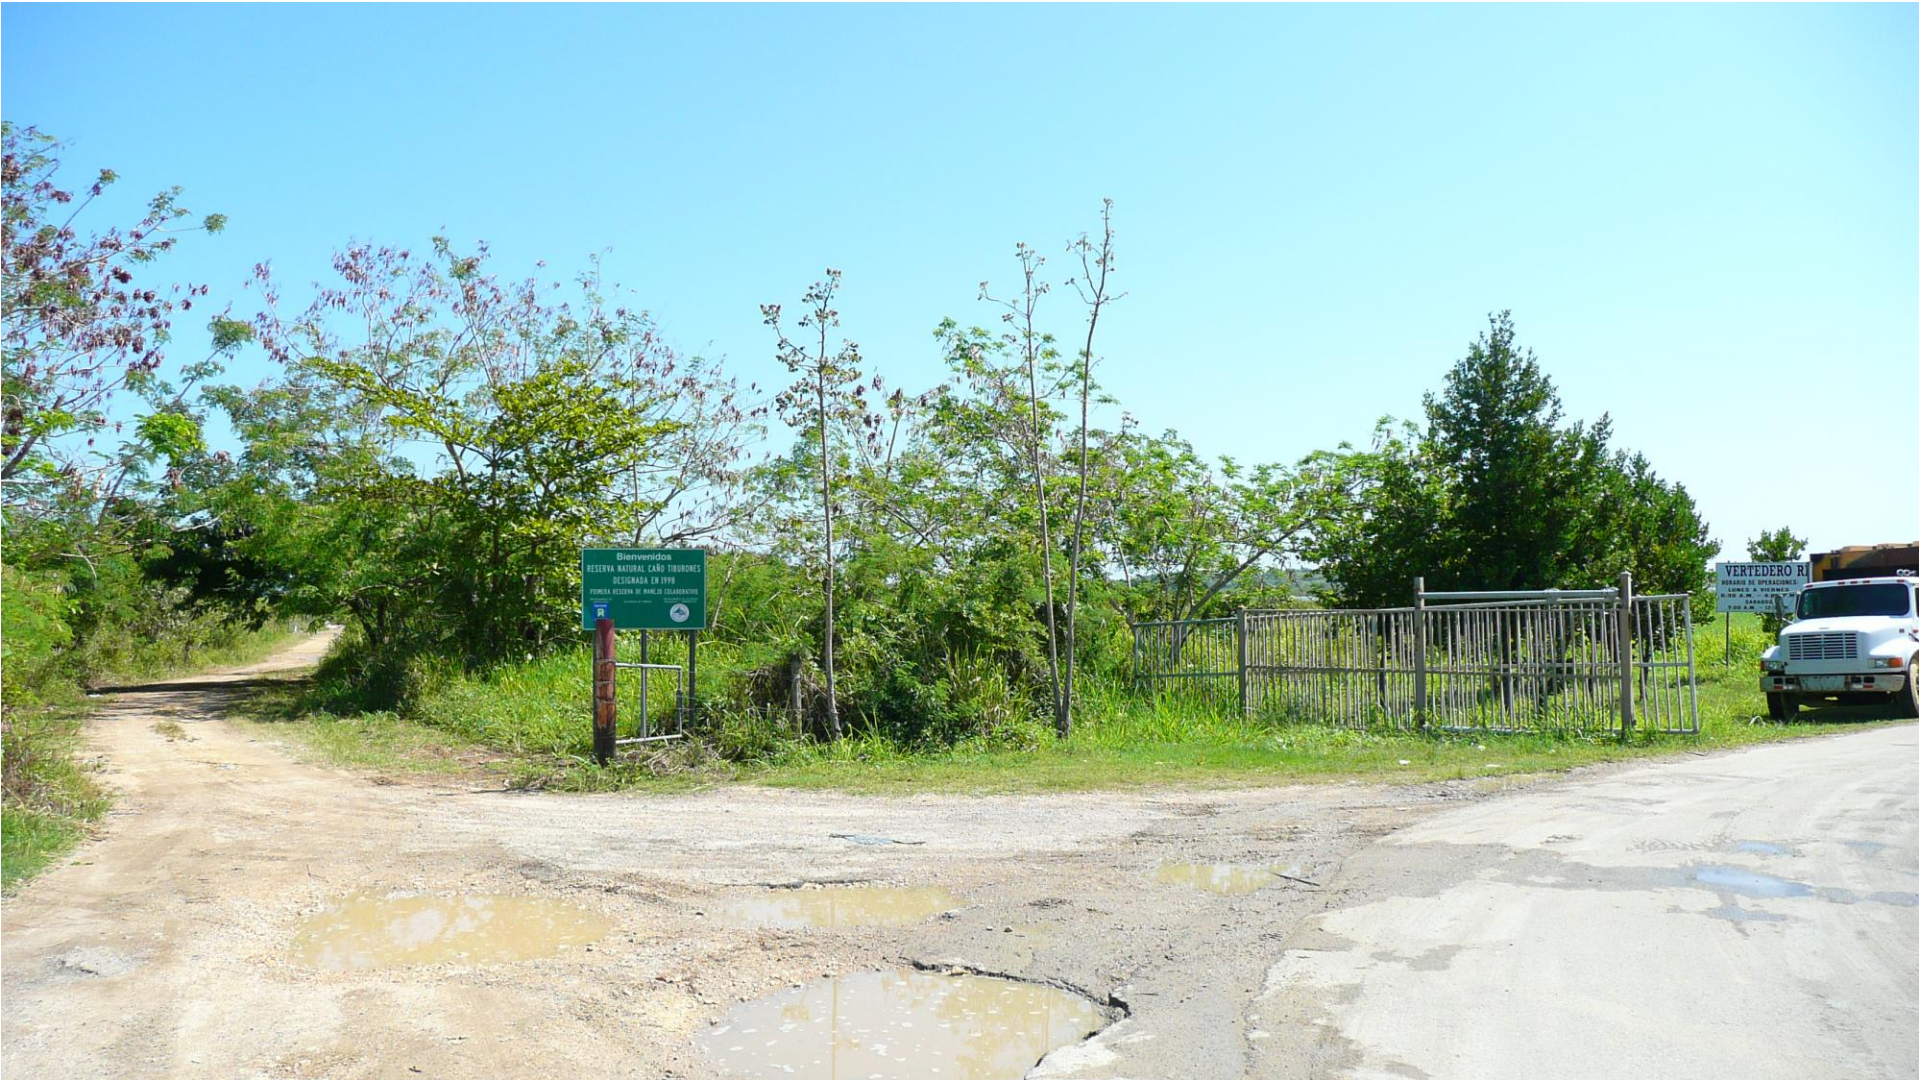
Entrance to Landfill (right) and Natural Reserve (left)

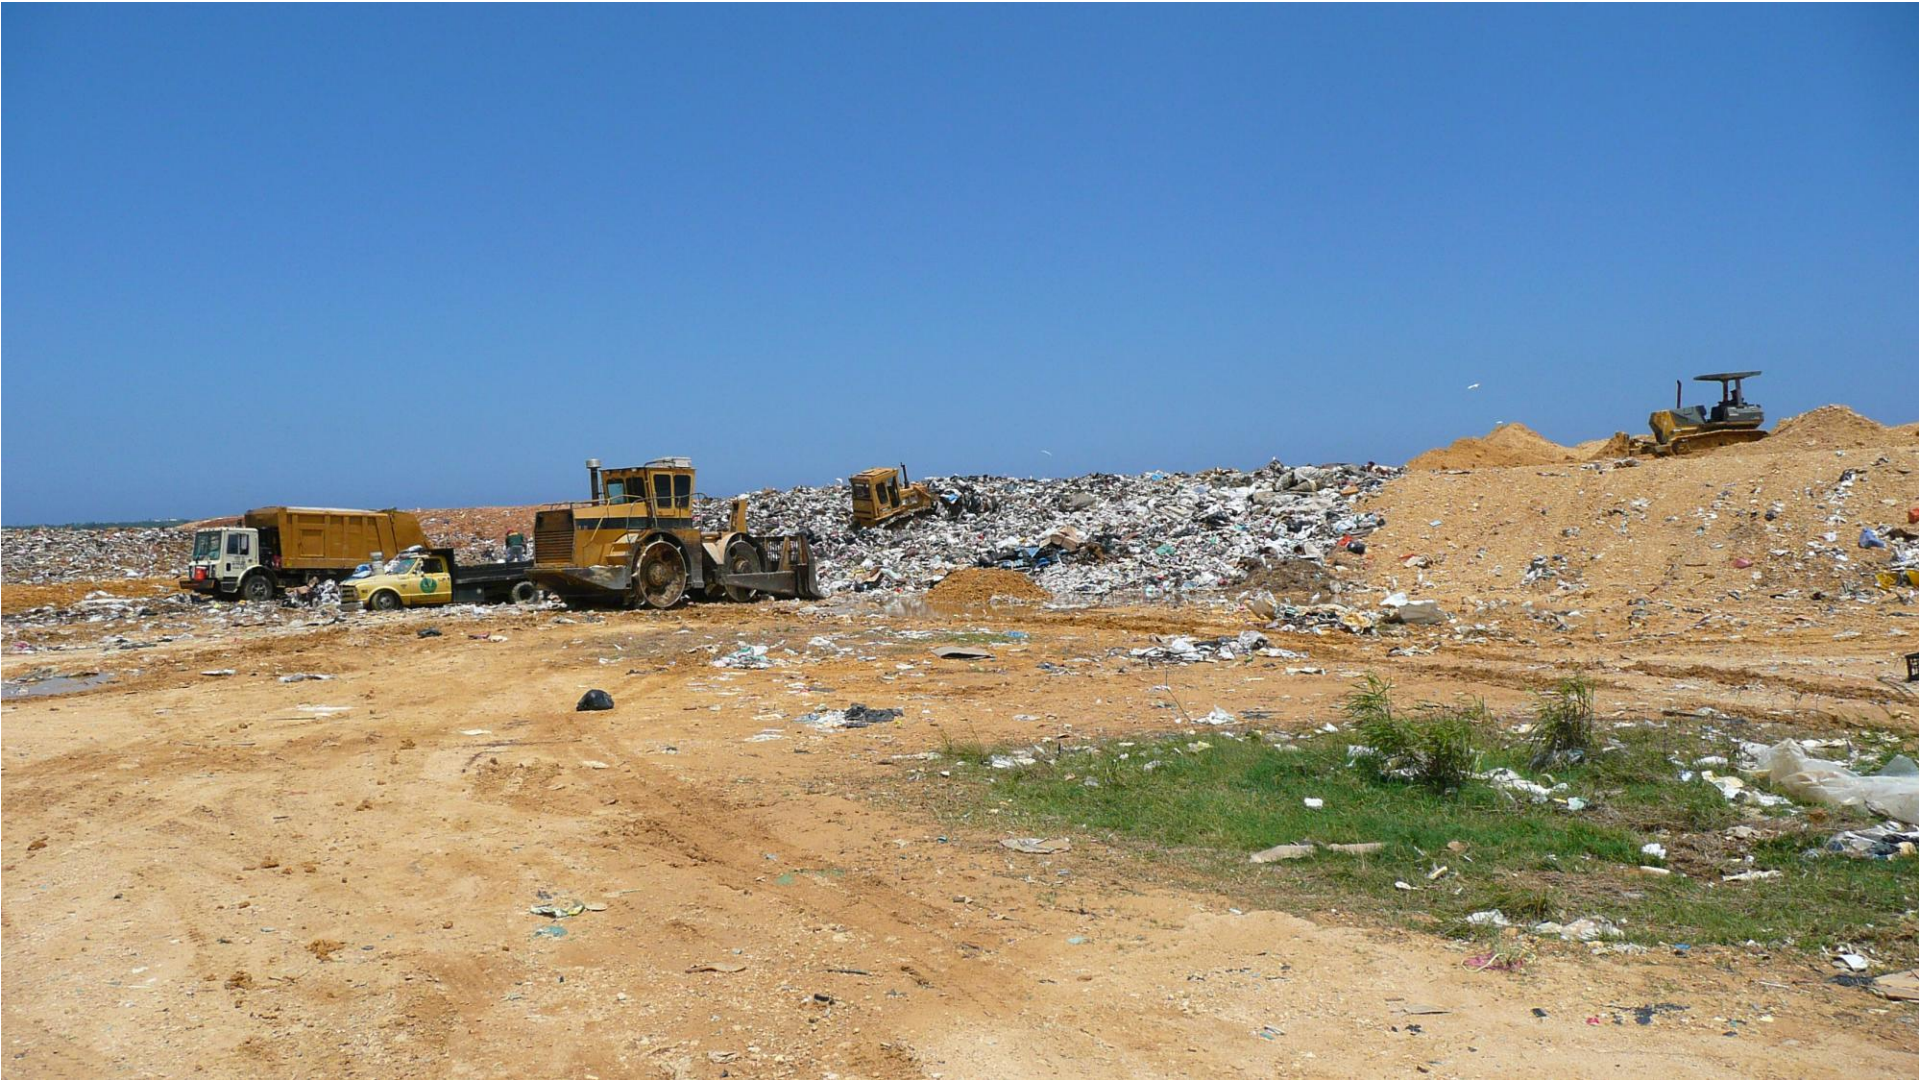
Operating face. Note: use of both 'dozers and landfill compactors (better compaction).

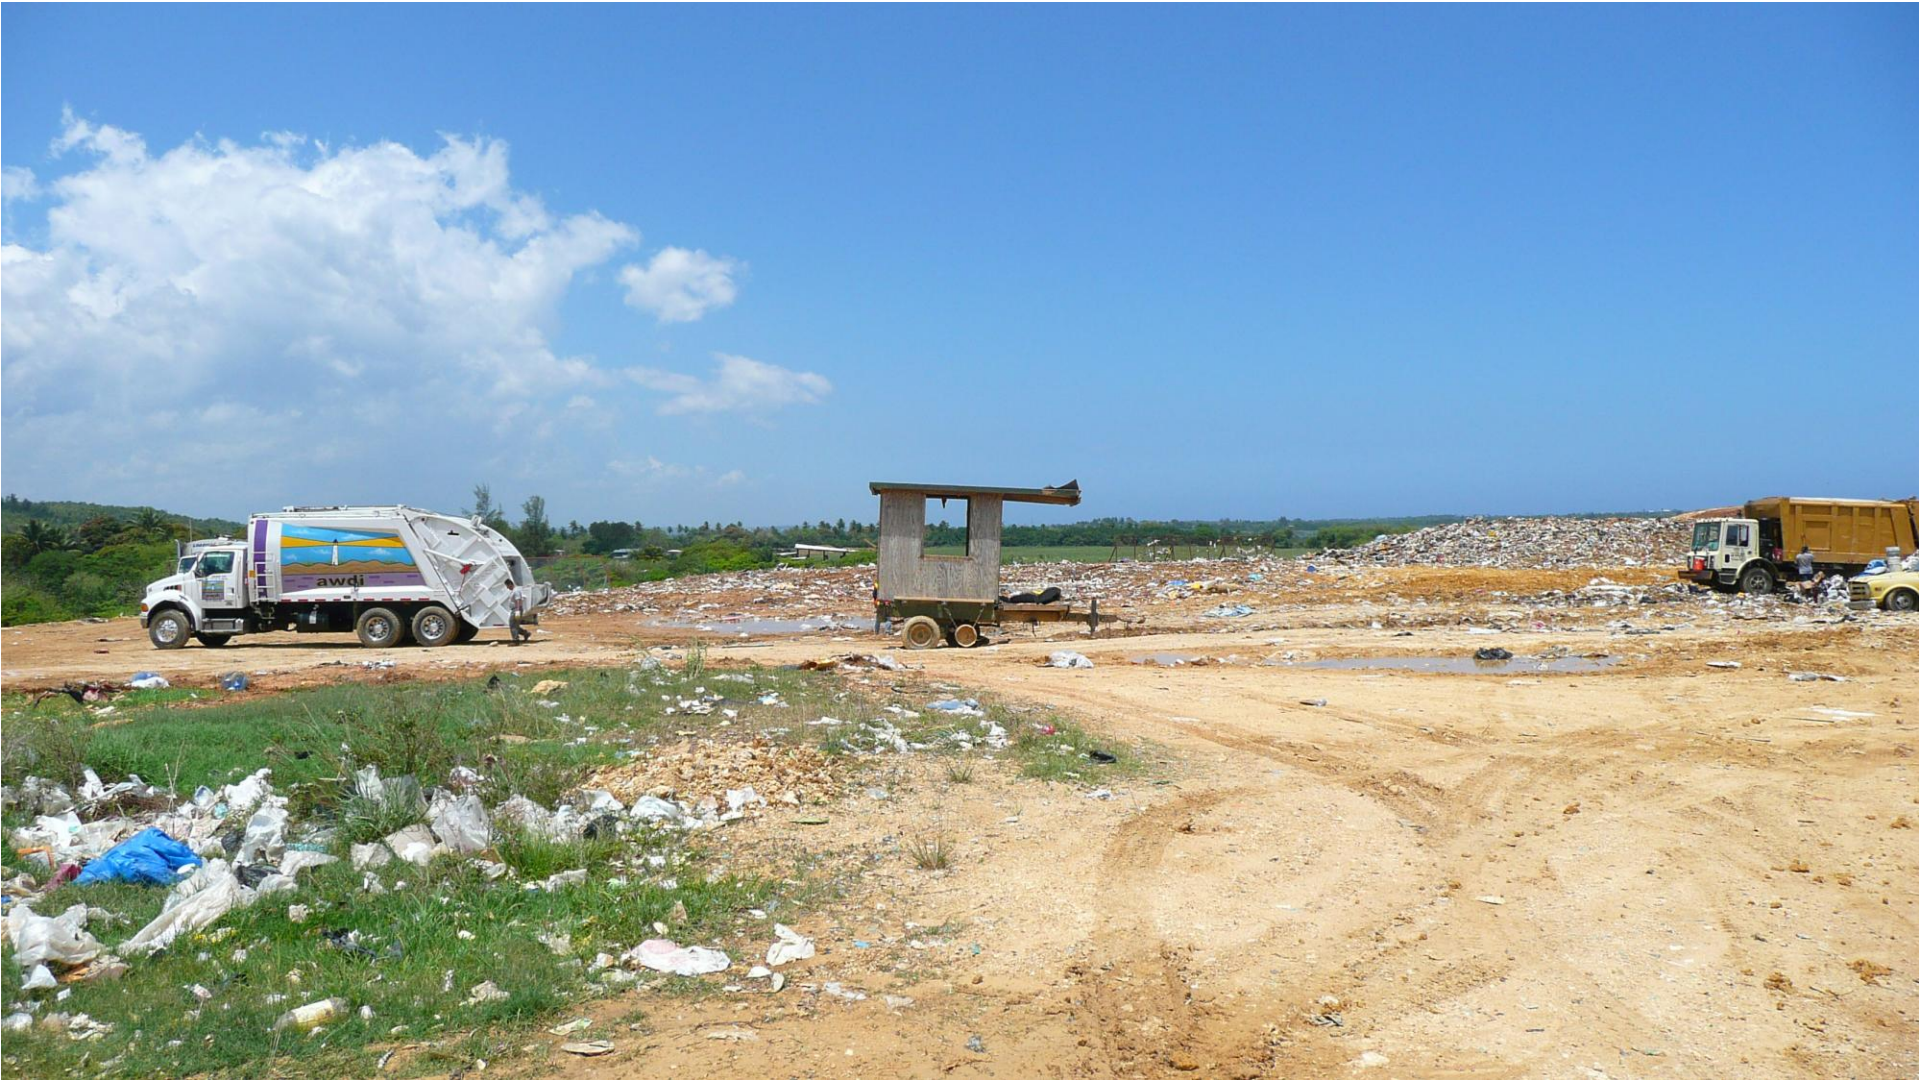
Exposed trash in non-active areas indicates areas of poor daily cover or eroded cover. Also, windblown trash.

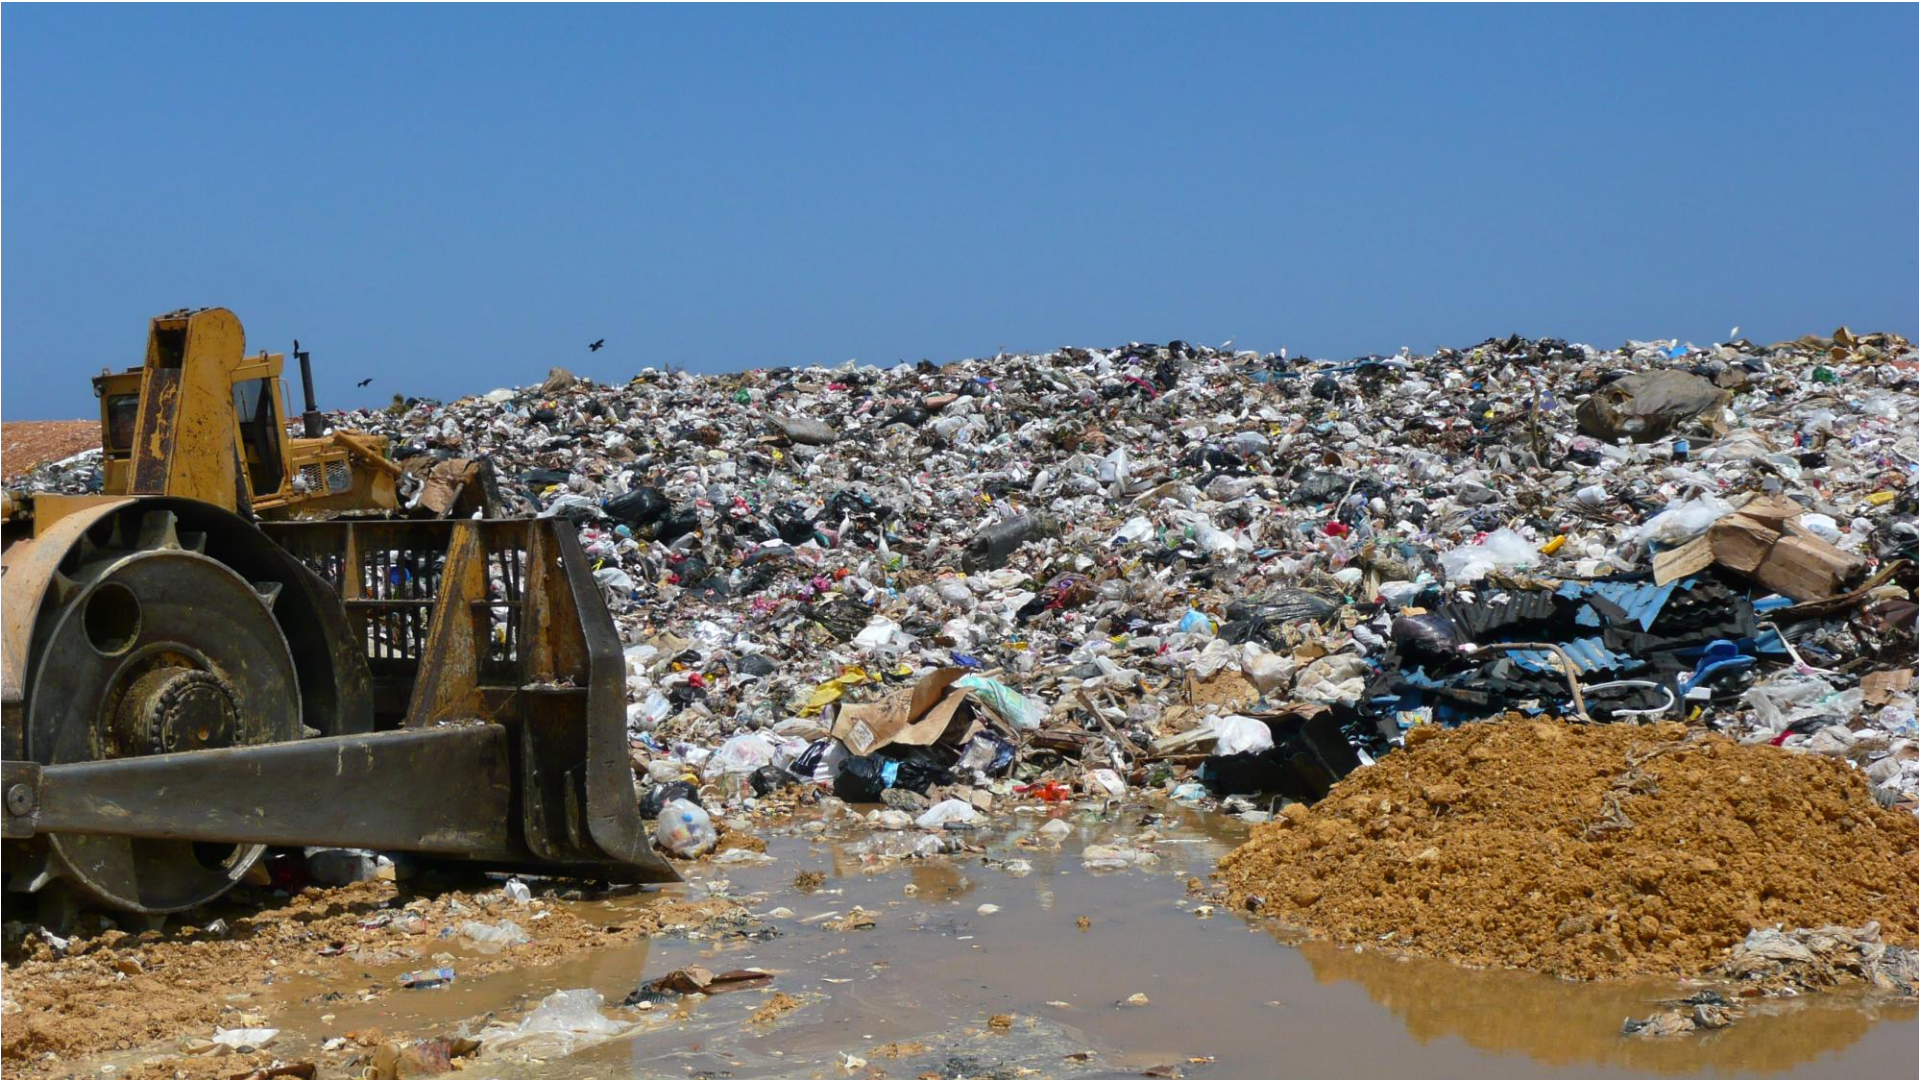
Operating face. Note: ponding.

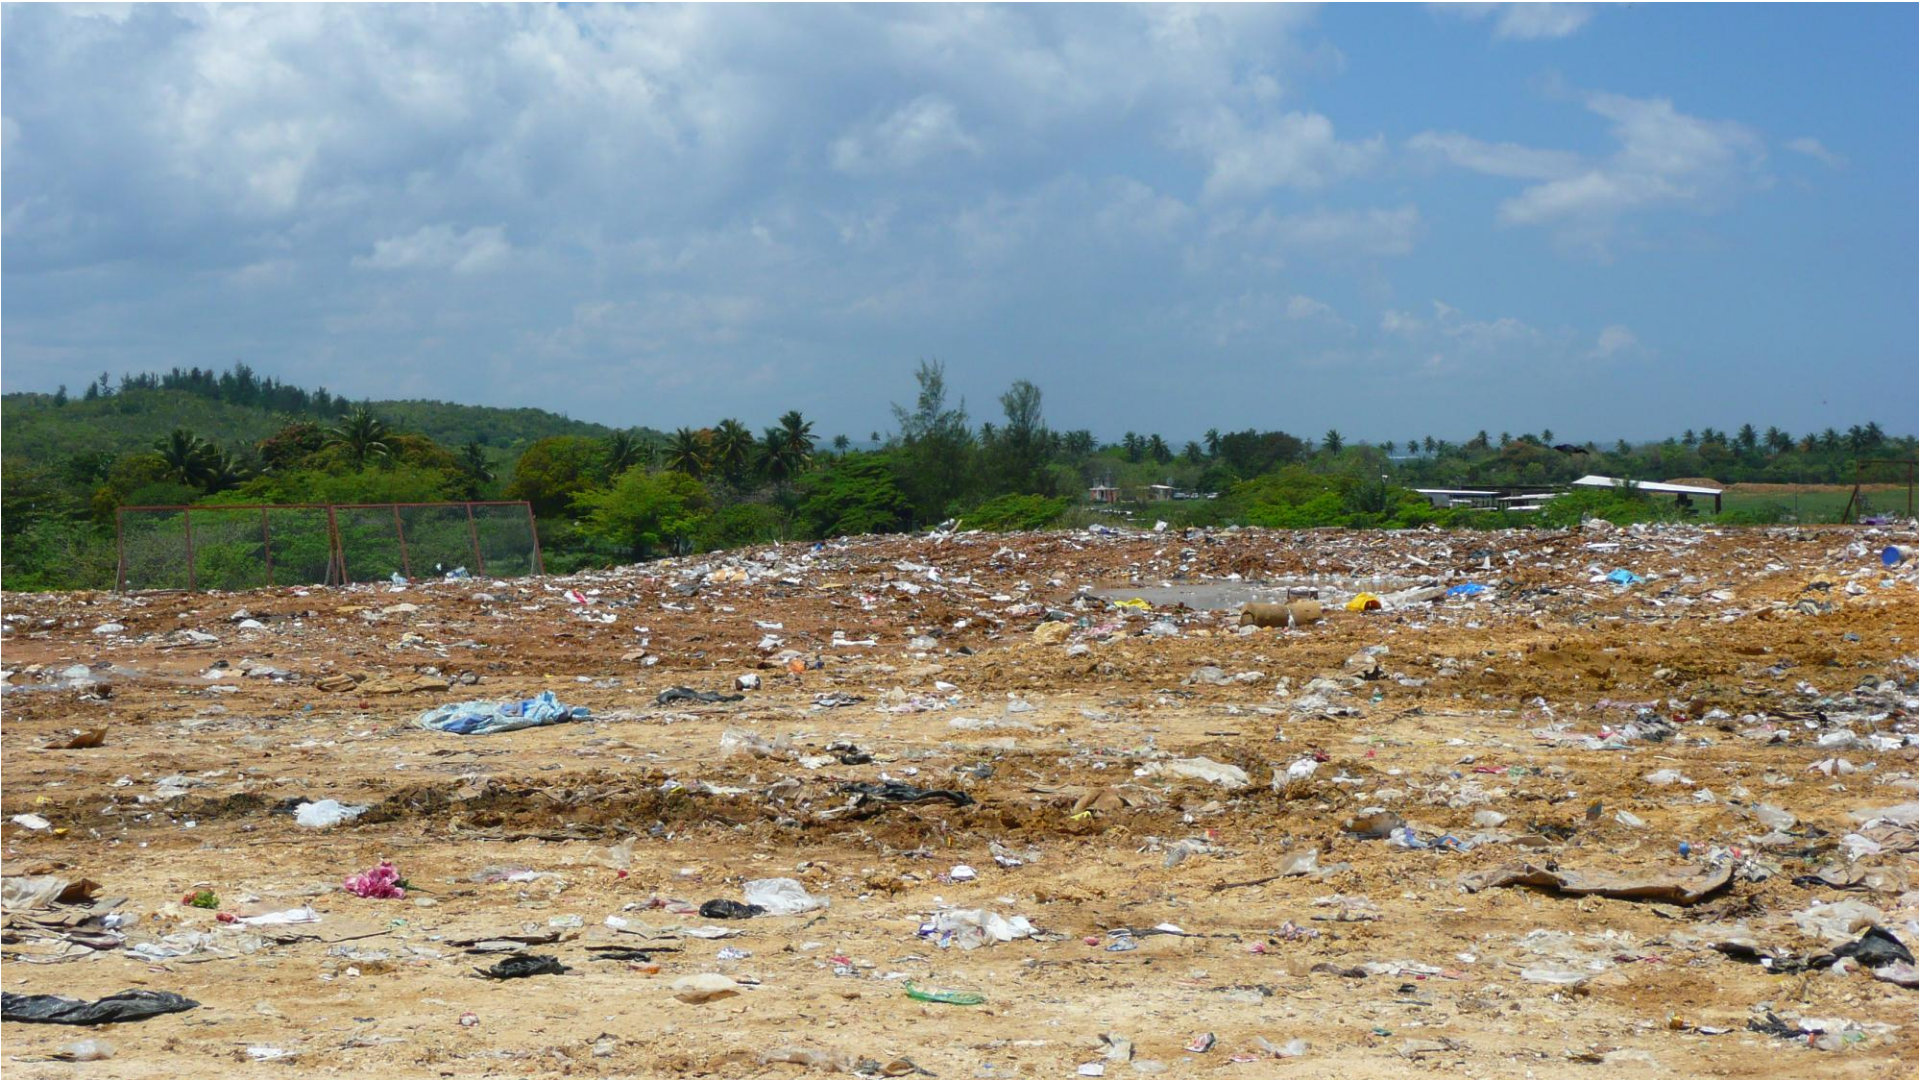
Exposed trash in non-active areas indicates areas of poor daily cover or eroded cover.

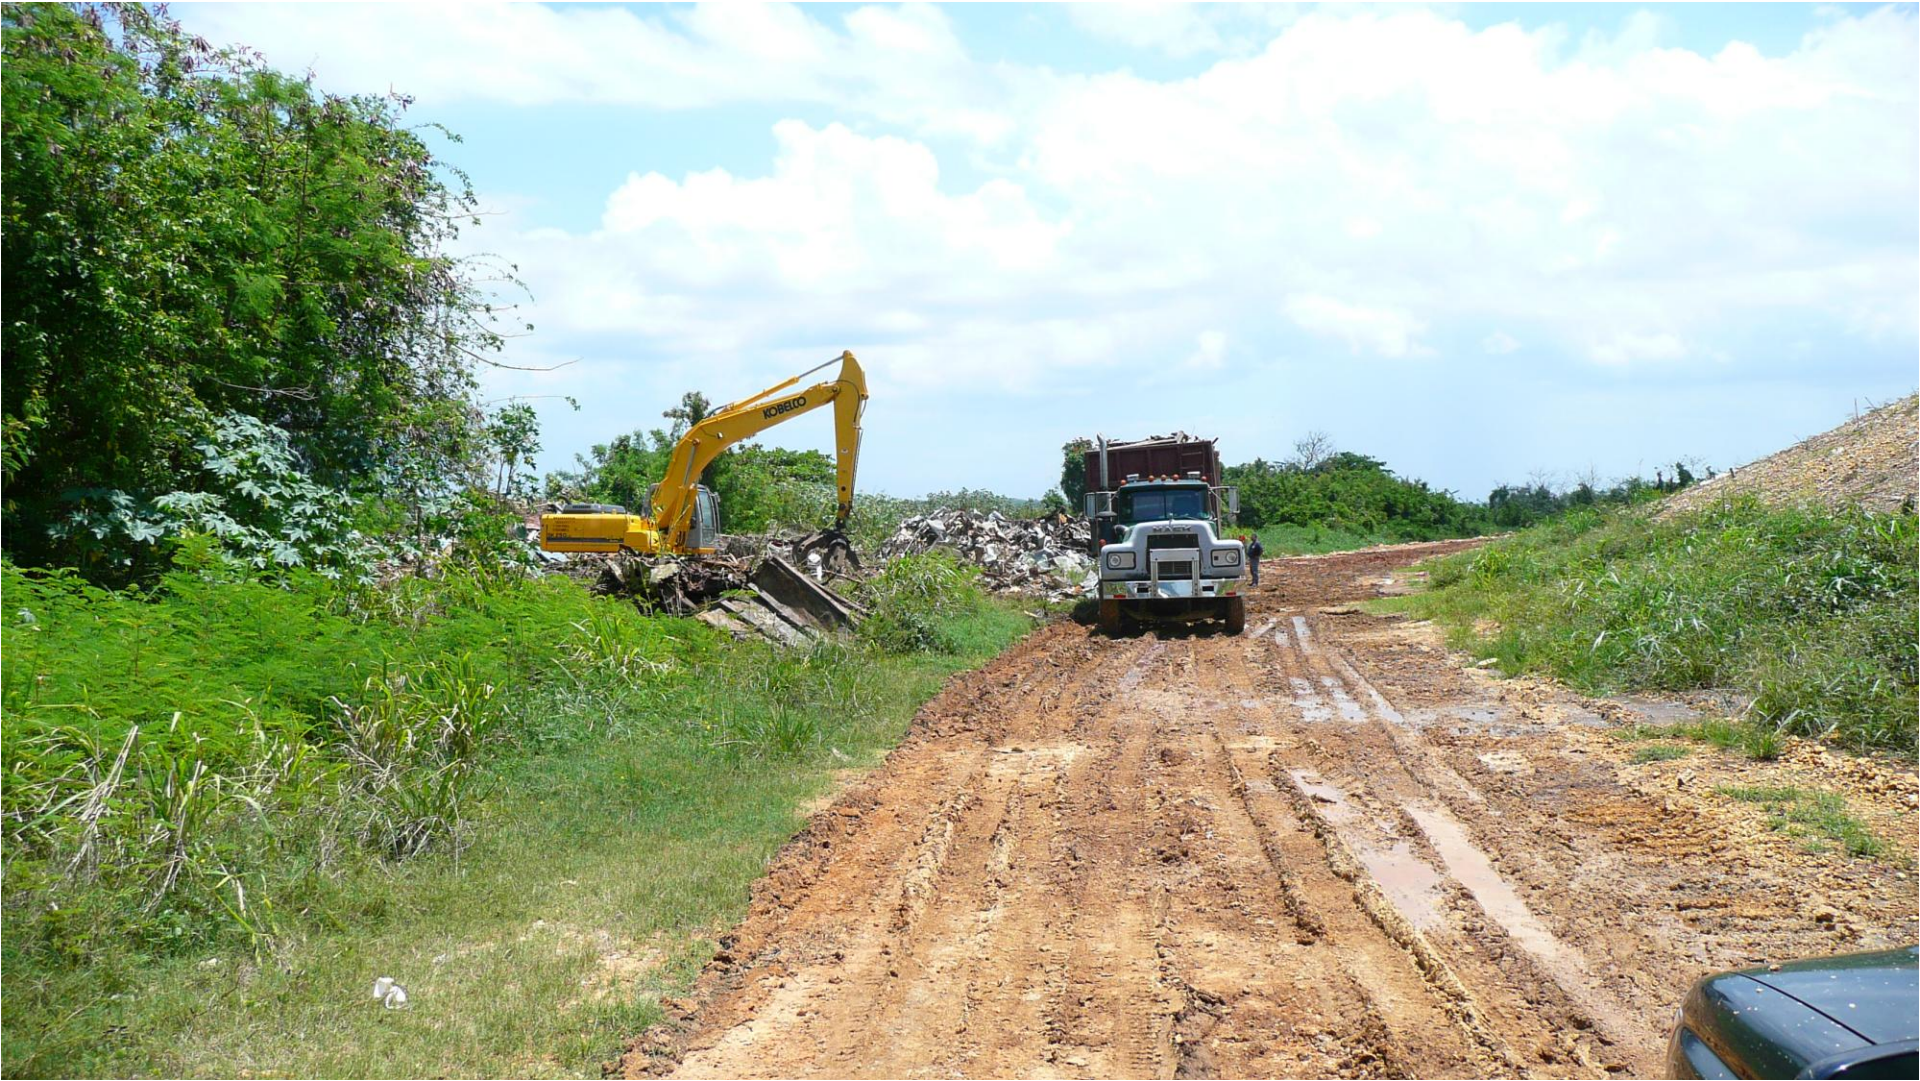
Scrap metal recovery operations from off-site (road is along property line—landfill is to the right).

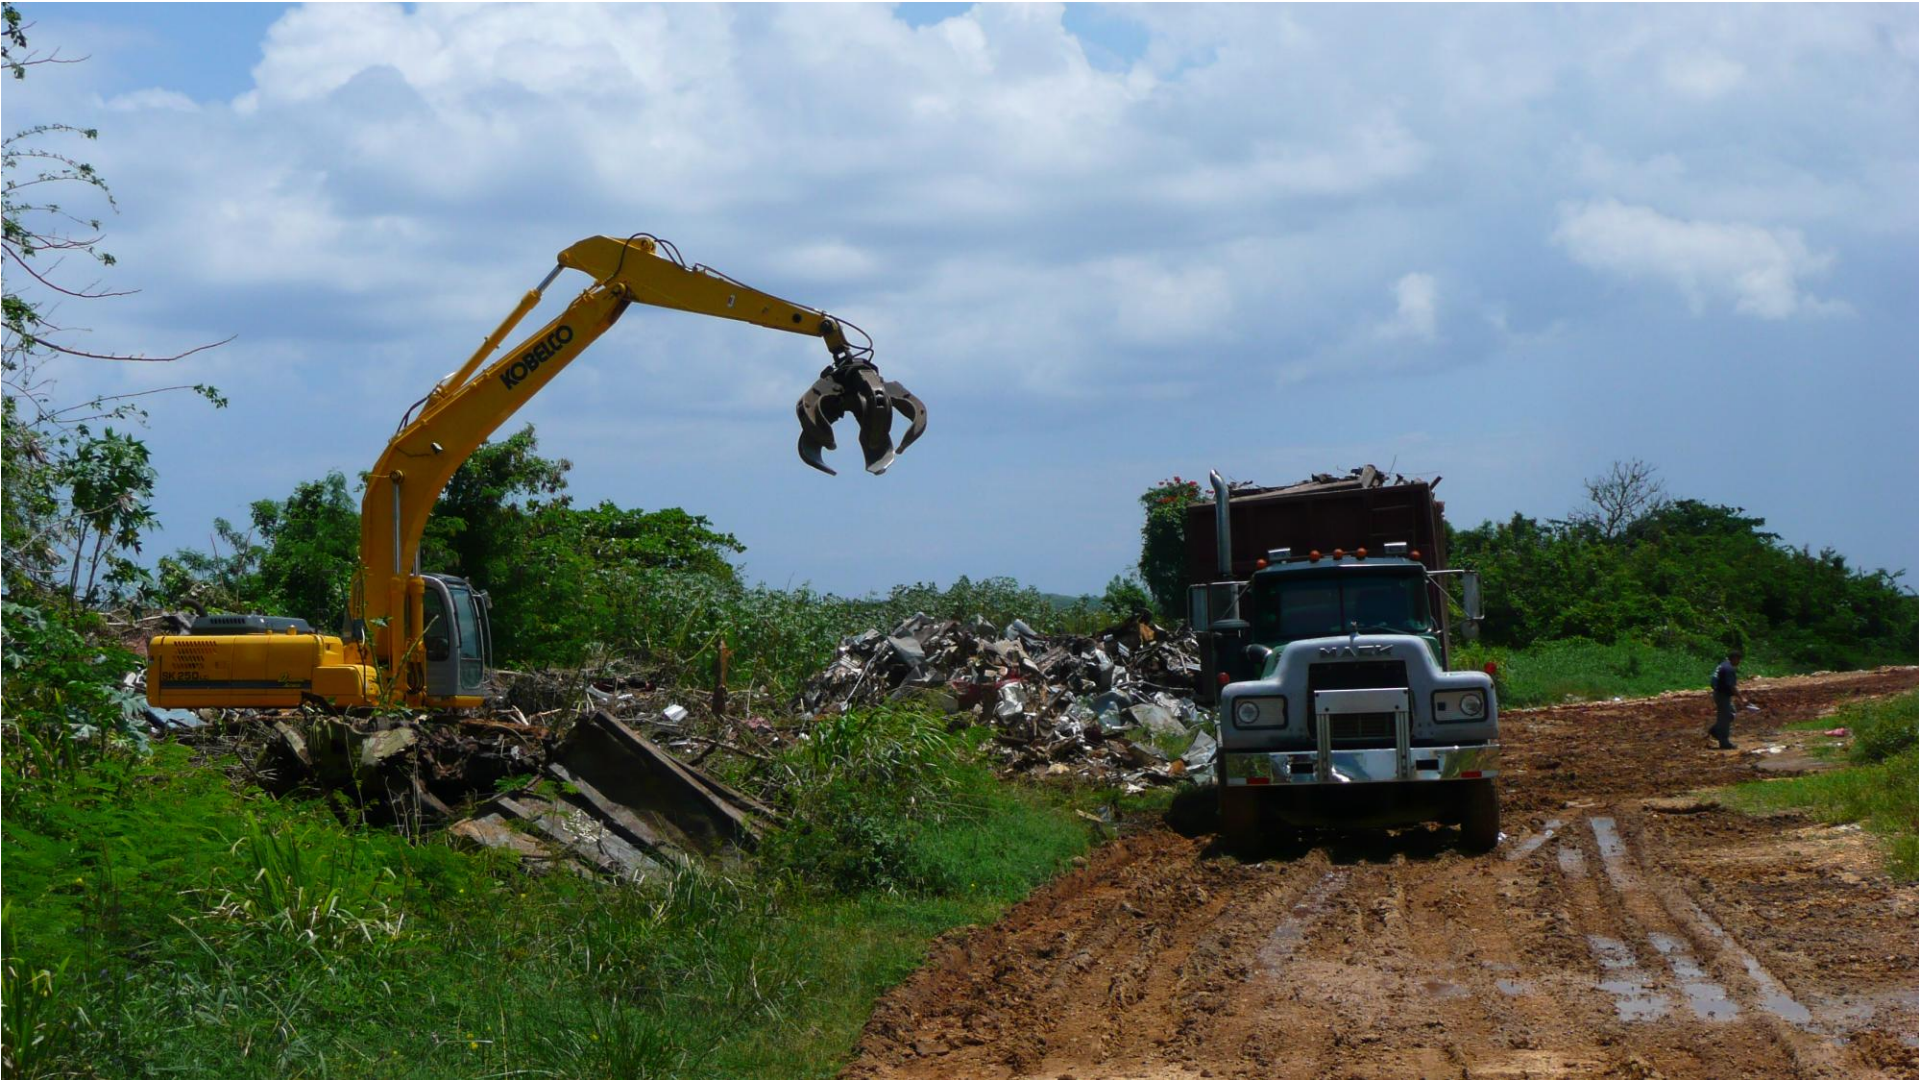
Scrap metal recovery operations from off-site (road is along property line—landfill is to the right).
